Manhole Inspection Summary

Manhole # S06AA2002MH

Insp Date: **6/28/06 1:47 PM**

Location Address: **3923 FALLSTAFF RD**

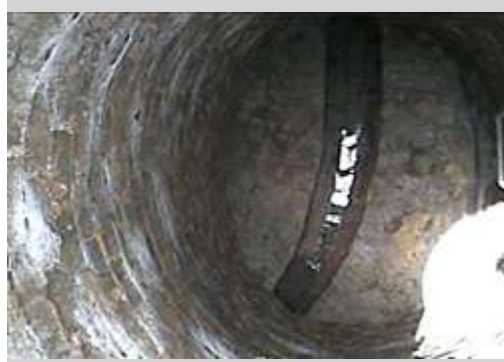
Top View

Adjustment and Corbel deterioration and infiltration. Evidence of surcharge - Bench debris.

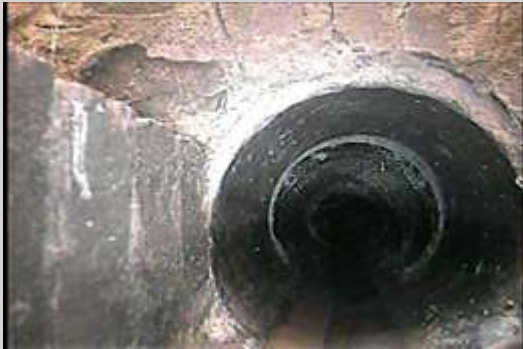
8 in. Circular Gravity Sewer Pipe Out @ 12 O'Clock

Deposits: ☐ None ☐ Mud ☐ Sludge ☒ Debris ☒ Grease

Silt Depth: **0** (in.) Deposits Extent: **Light**

Infiltration: **Evidence** Pipe Seal Cond: **Unknown**
